4.6.2019 Analyses and Repair of the 6m LFA

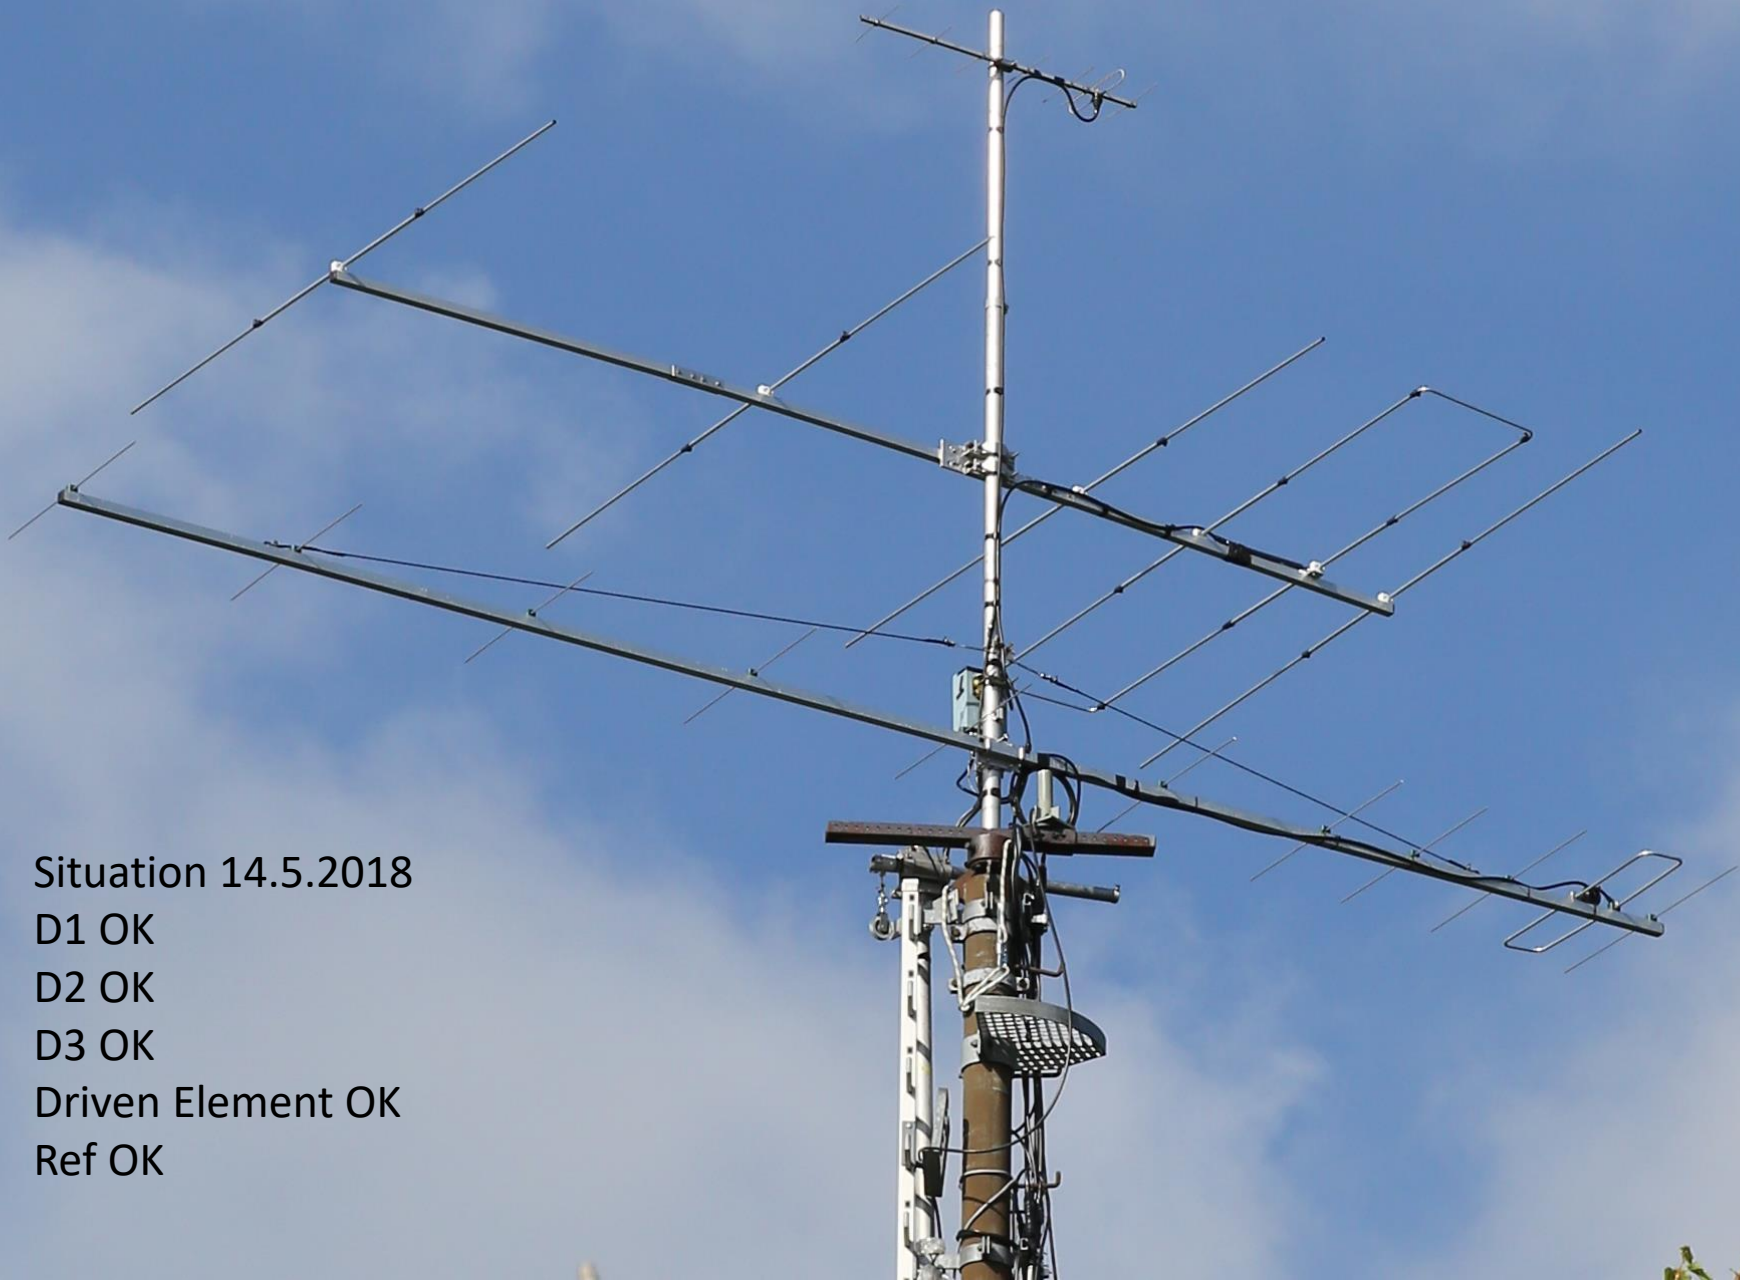
Situation 14.5.2018

D1 OK

D2 OK

D3 OK

Driven Element OK

Ref OK

Situation 11.07.2018

«swinging» element filmed

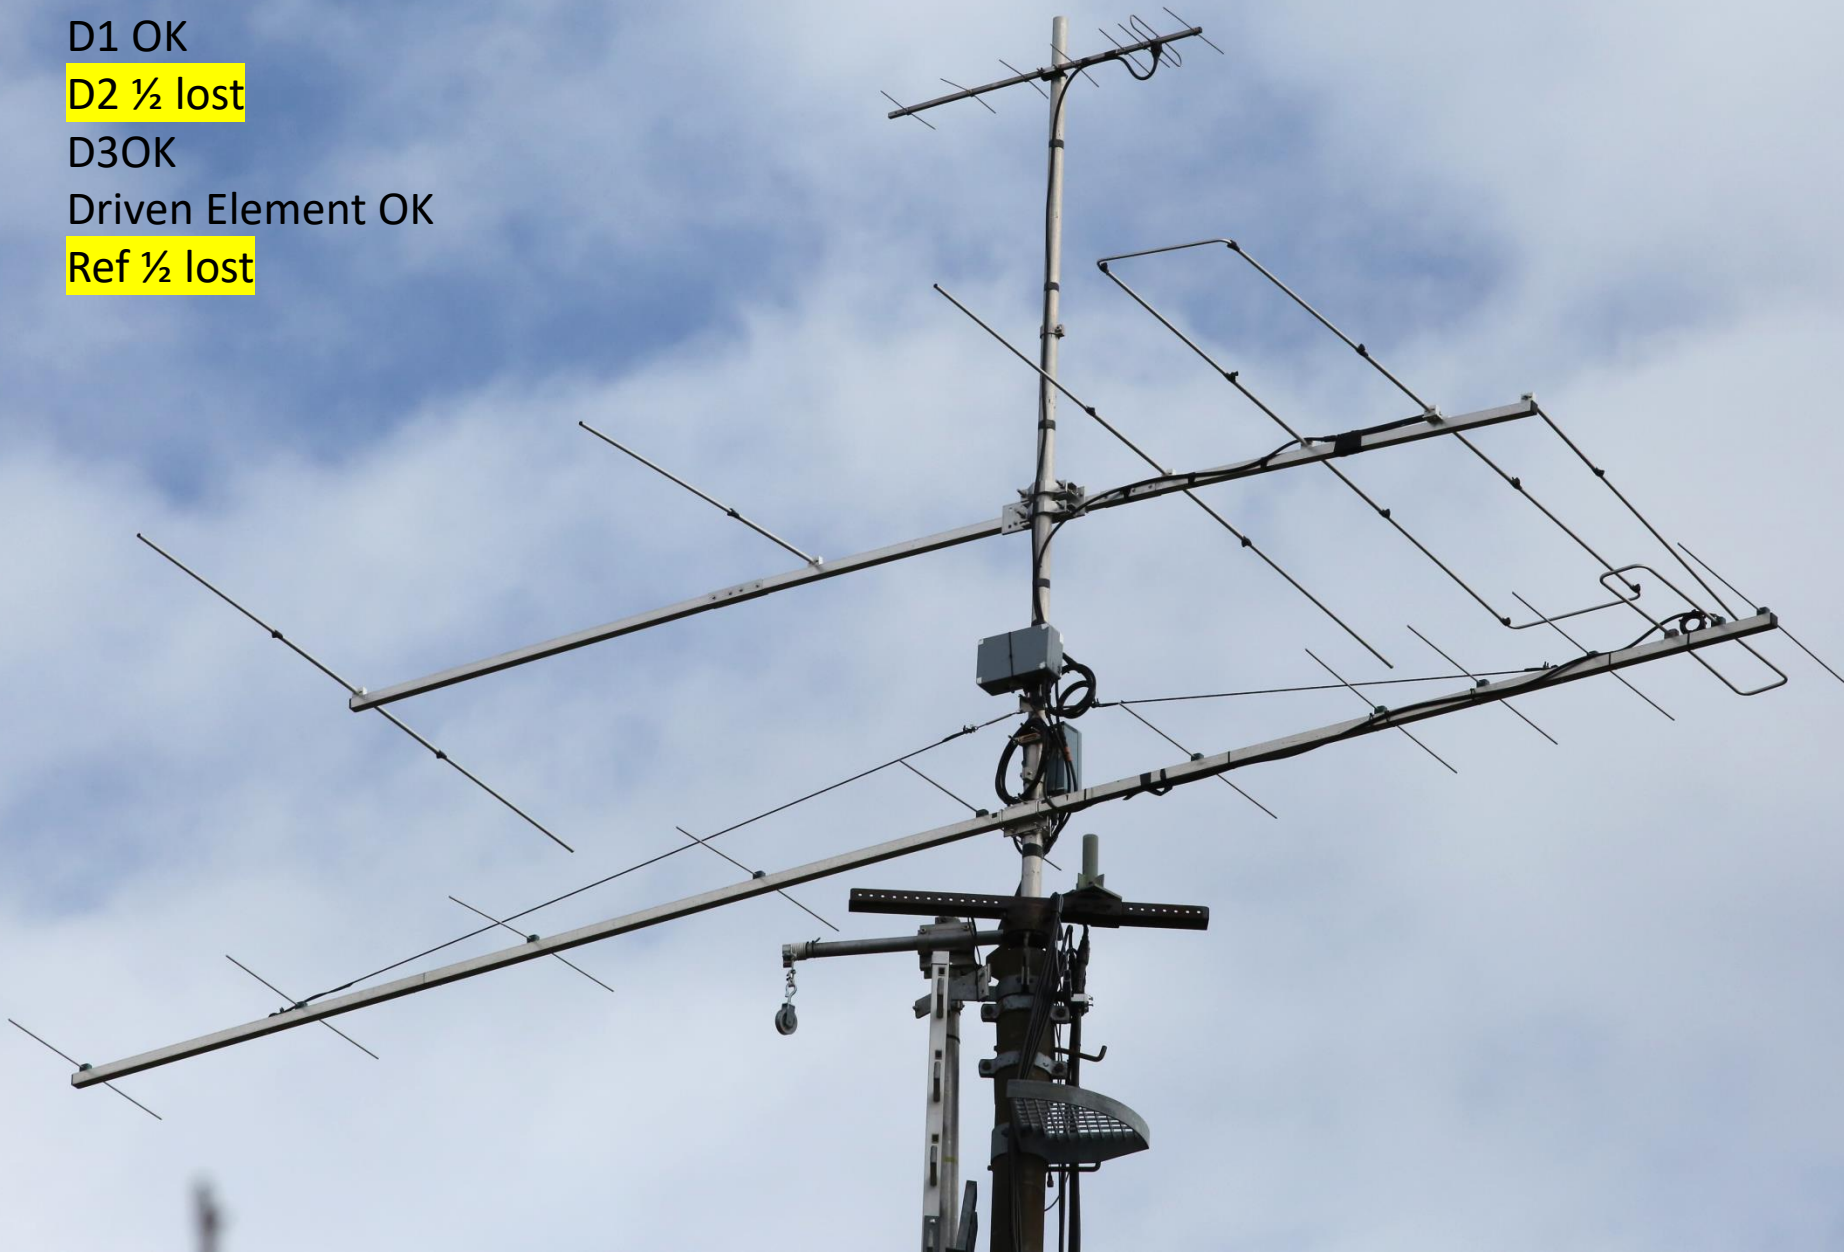
Situation

10.11.2018

D1 OK

D2 ½ lost

D3OK

Driven Element OK

Ref ½ lost

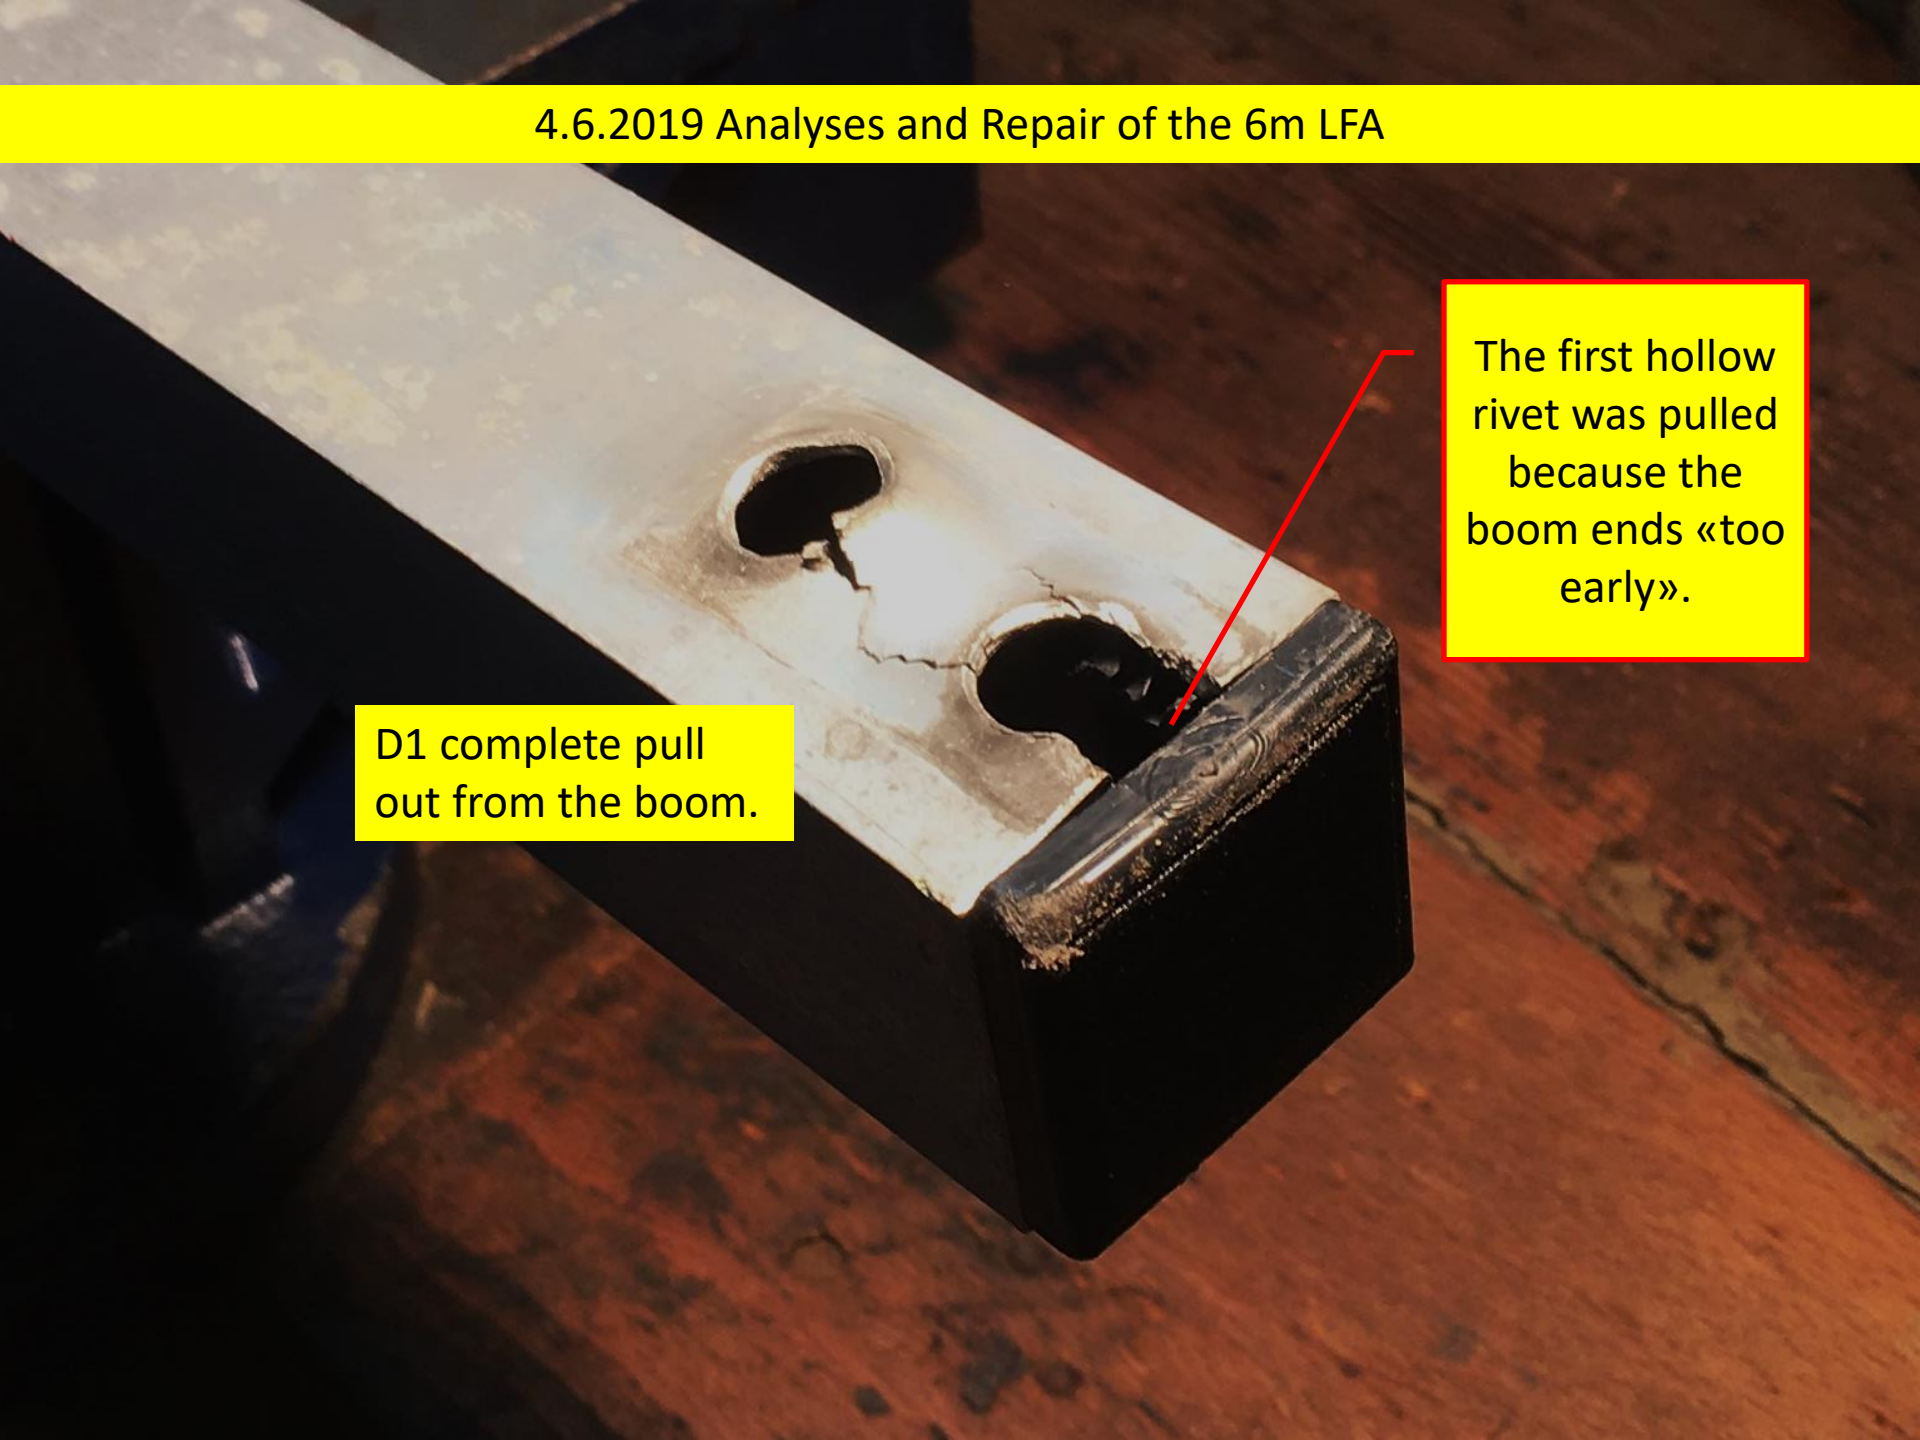
D1 complete pull out from the boom.

The first hollow rivet was pulled because the boom ends «too early».

>> Decision to fix all elements thru the boom and secure with safety nut. Add material to strengthen the boom at both ends.

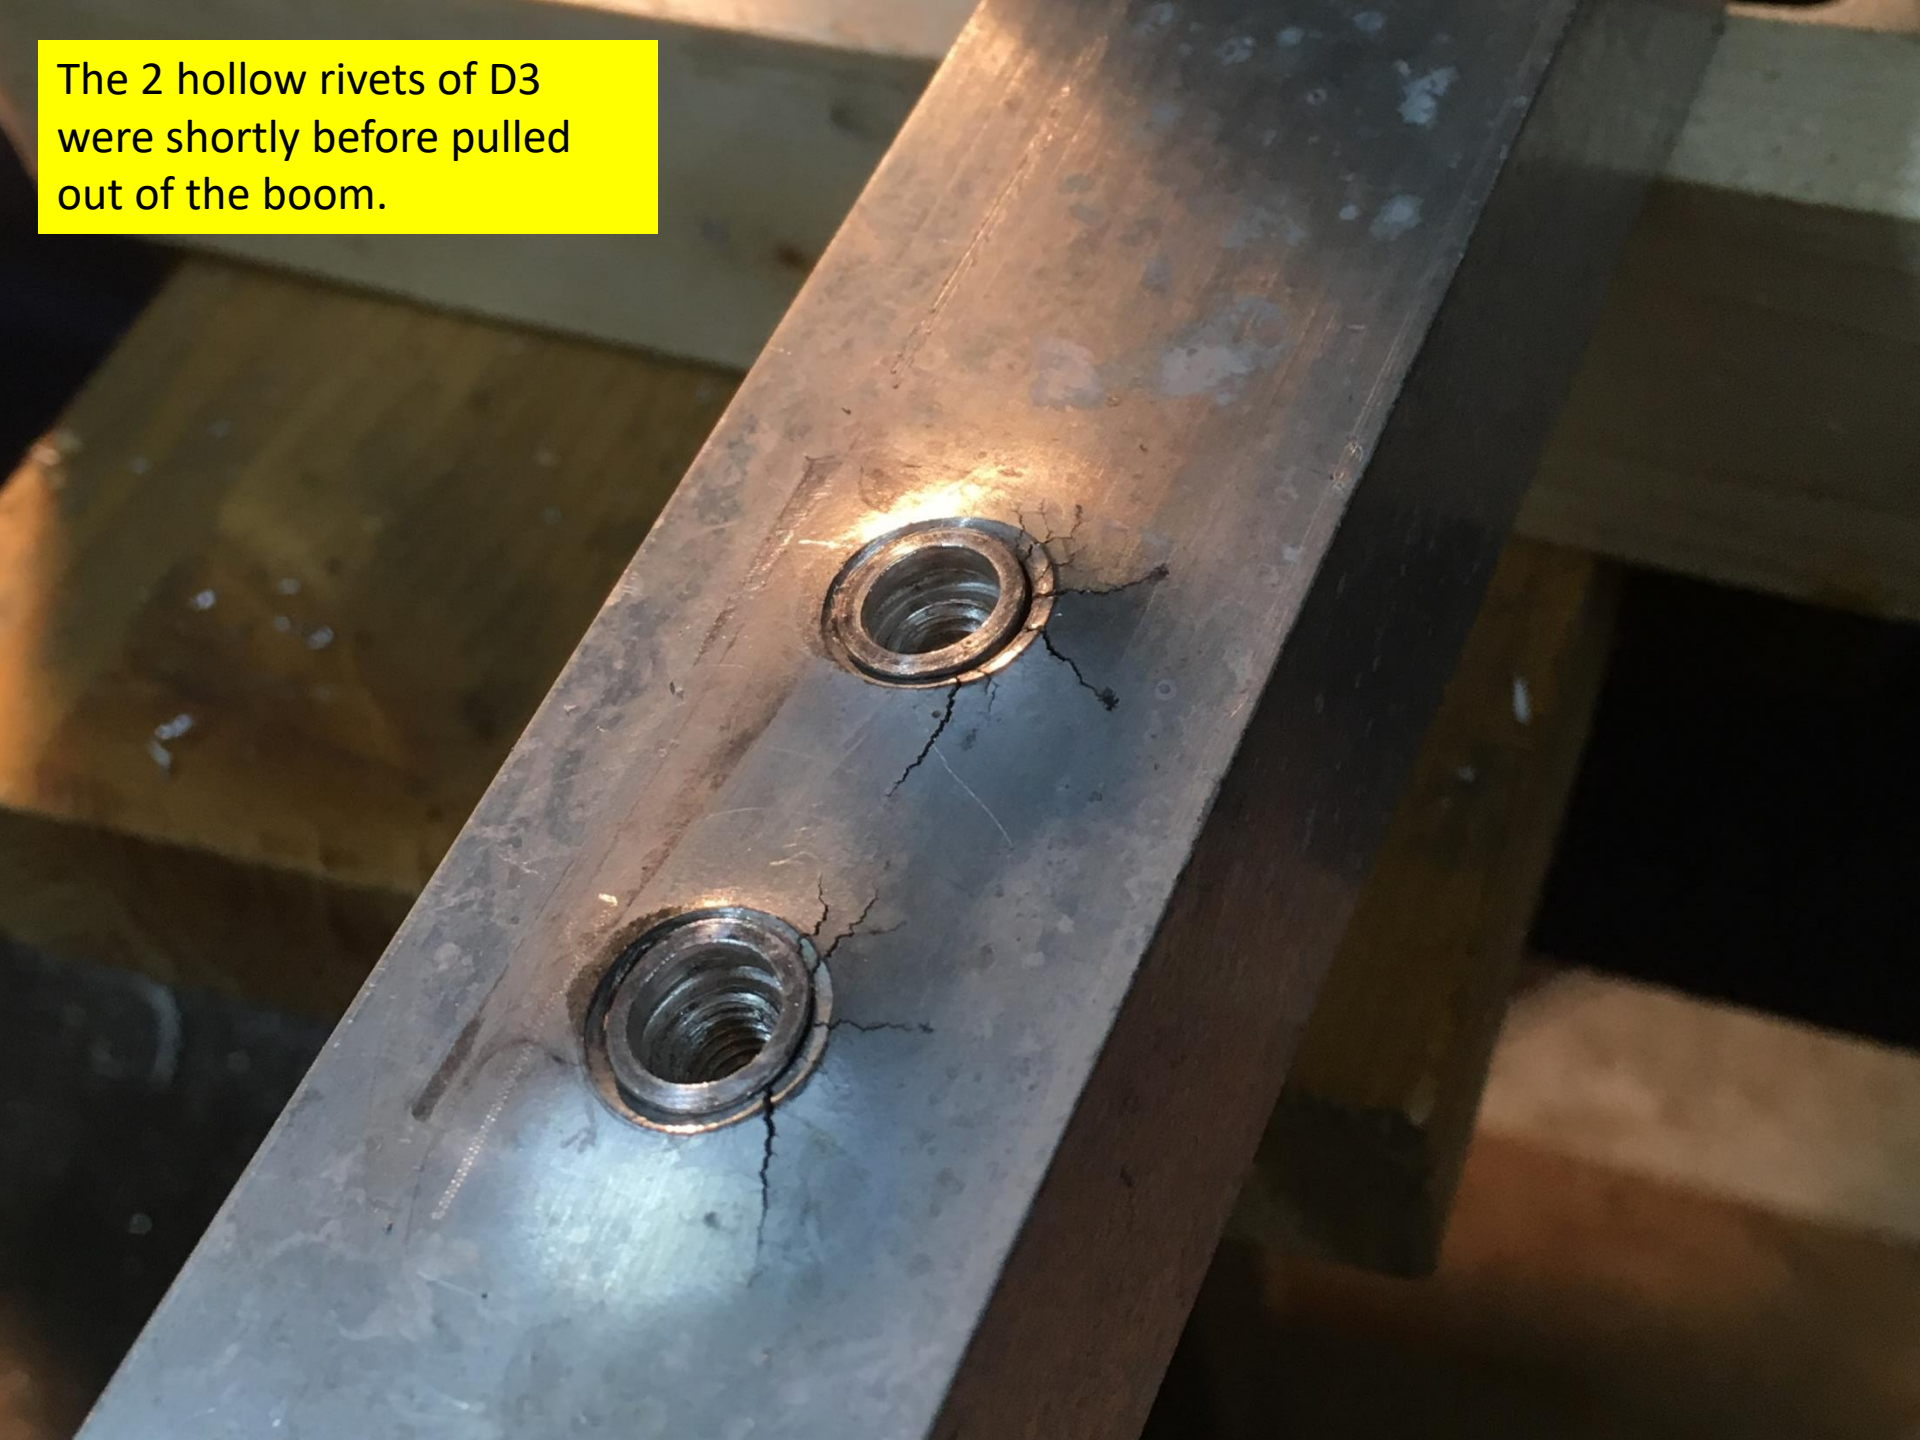
The 2 hollow rivets of D3 were shortly before pulled out of the boom.
